Rimkus Consulting Group, Inc.
Eight Greenway Plaza, Suite 500
Houston, TX 77046
(800) 580-3228 Telephone
(713) 623-4357 Facsimile

Re: RCG File No: 11009971
LLV Number: 0209452
VMF Location: 1530 Greensmark Drive in Houston, Texas
Subject: Final Report

Rimkus Consulting Group, Inc. was retained to examine LLV 0209452, VIN 1GBCS10E4M2908832. The fire occurred on June 13, 2016 at around 12:30 P.M. the operator of the vehicle at the time of the fire, was unavailable for interview but reportedly stated the vehicle's engine died while delivering mail on his route and backfired during subsequent attempts to restart it. Soon thereafter, smoke was observed from beneath the hood as well as flames.

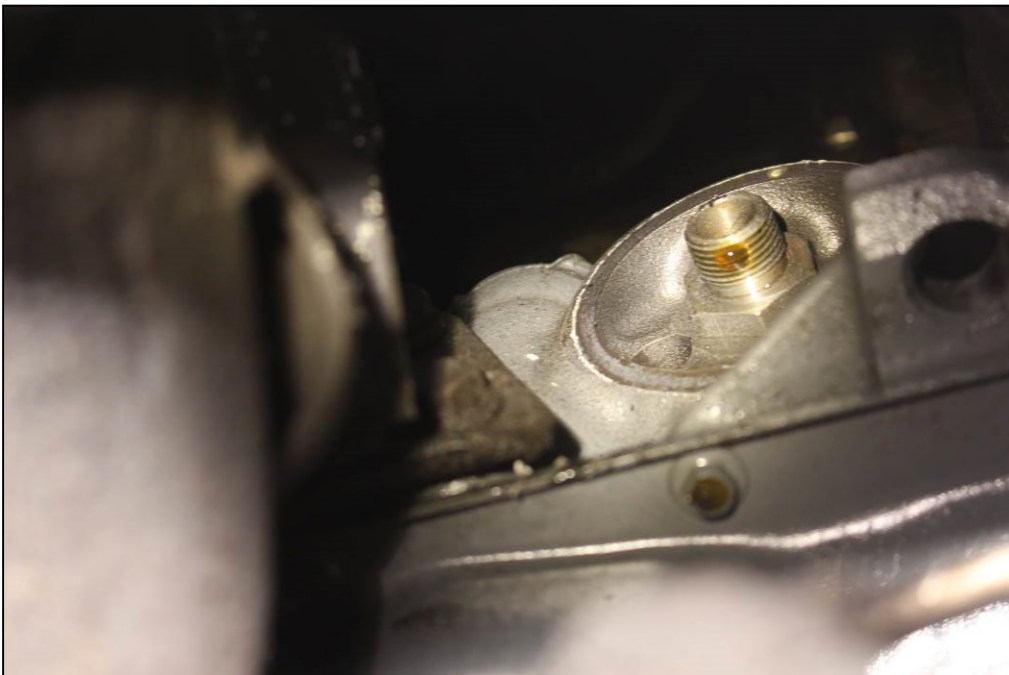
Photograph 6

Threaded metal post where the oil filter should attach.

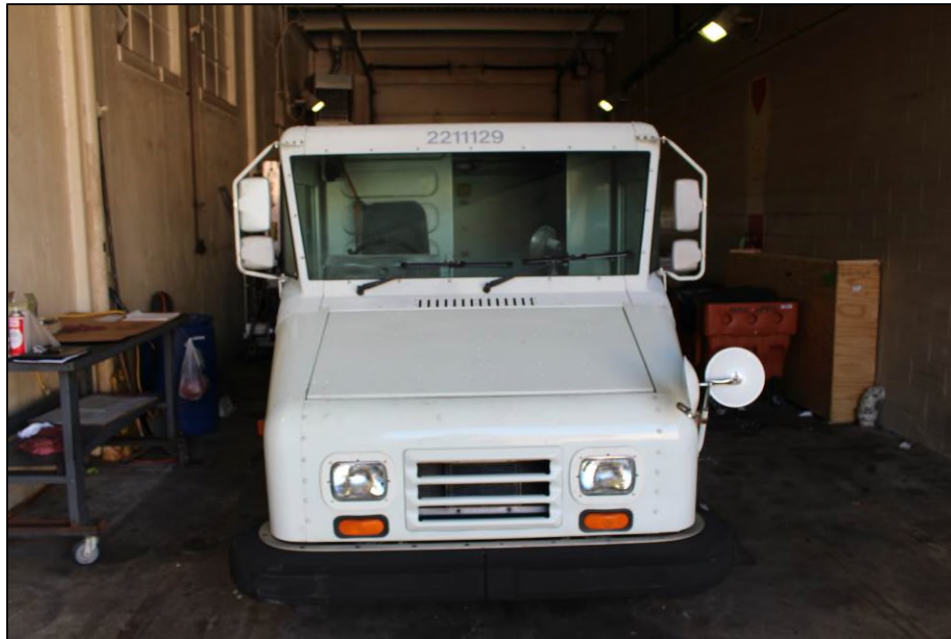
Photograph 1
Front of LLV.

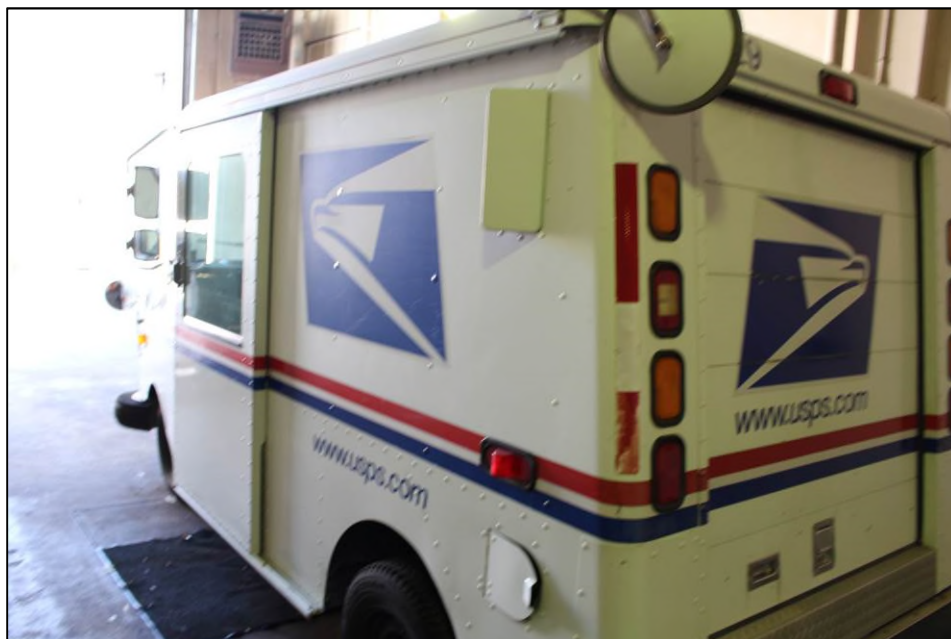
Photograph 2
Passenger side of LLV.

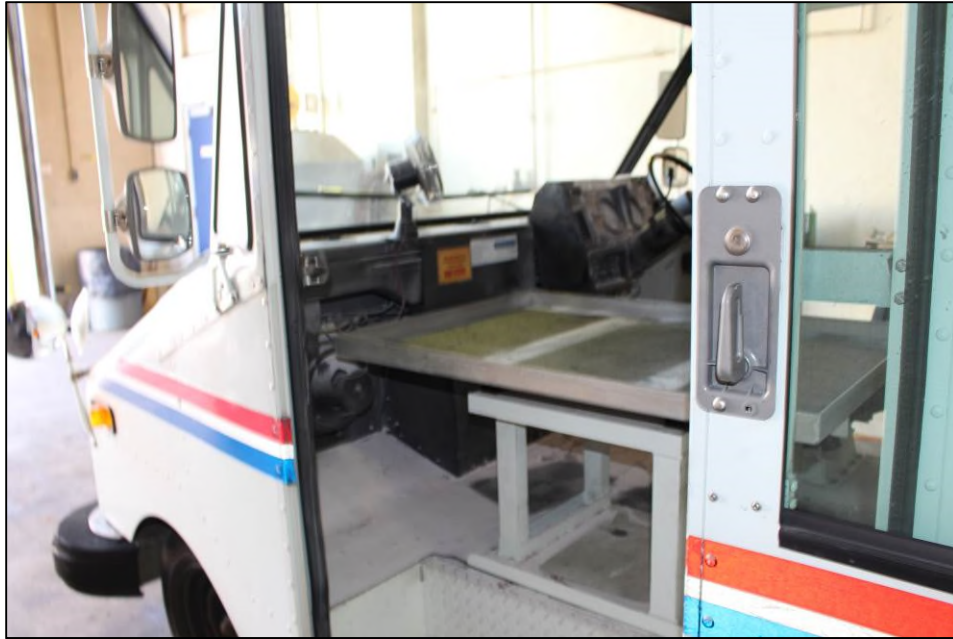
Photograph 3
Passenger area.

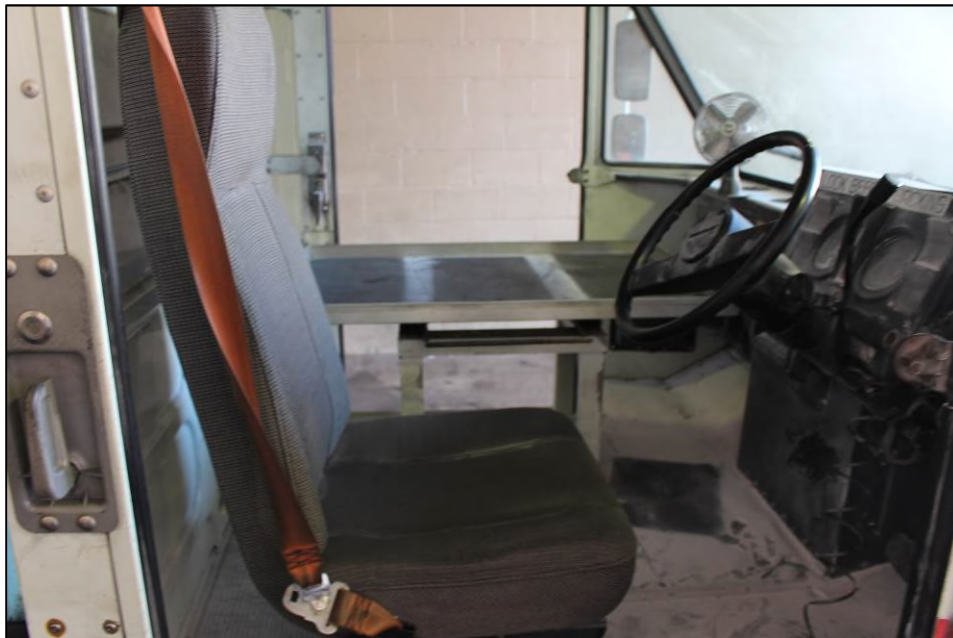
Photograph 4
Driver's area.

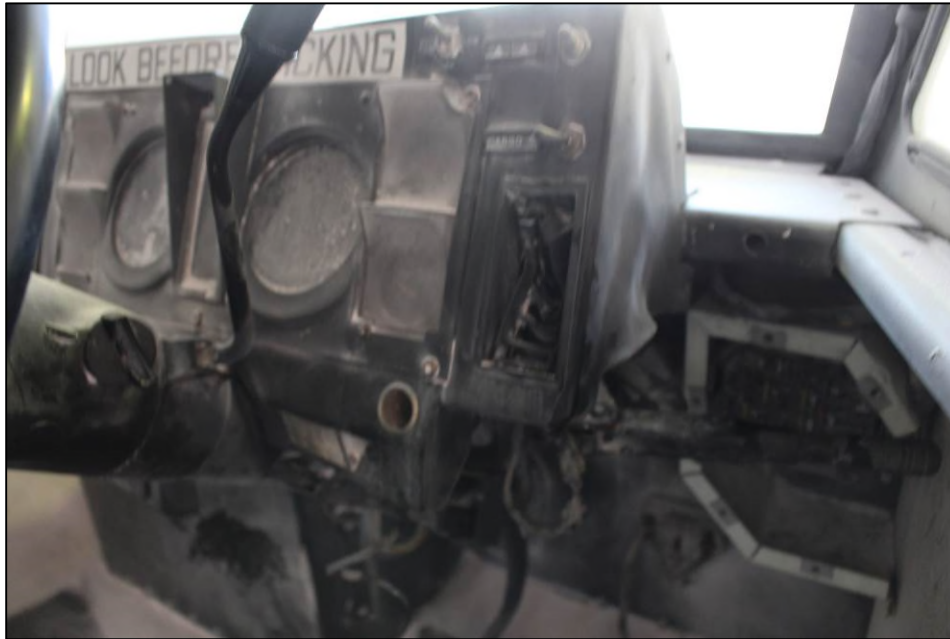
Photograph 5
Dashboard.

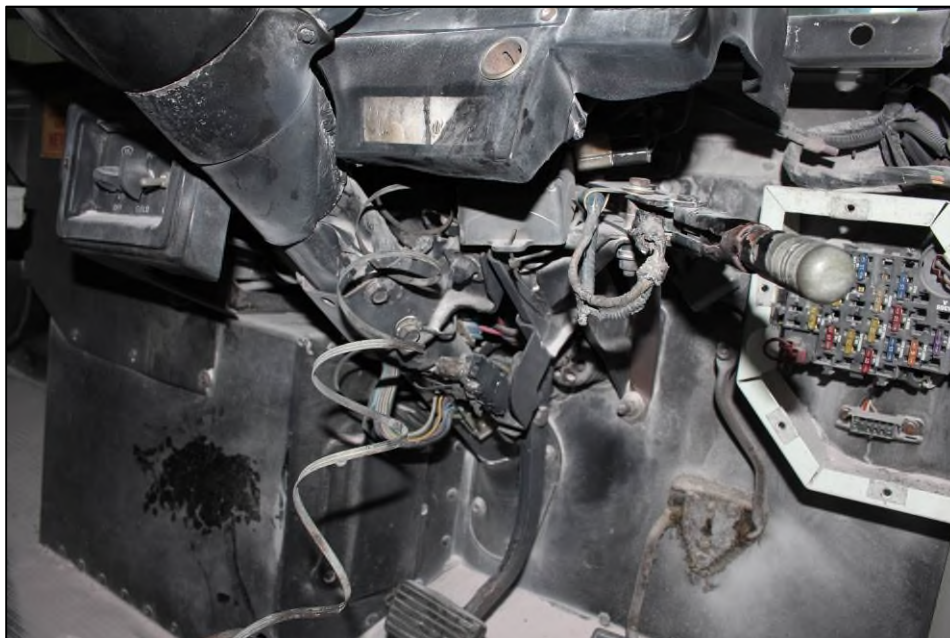
Photograph 6
Under side of dashboard.

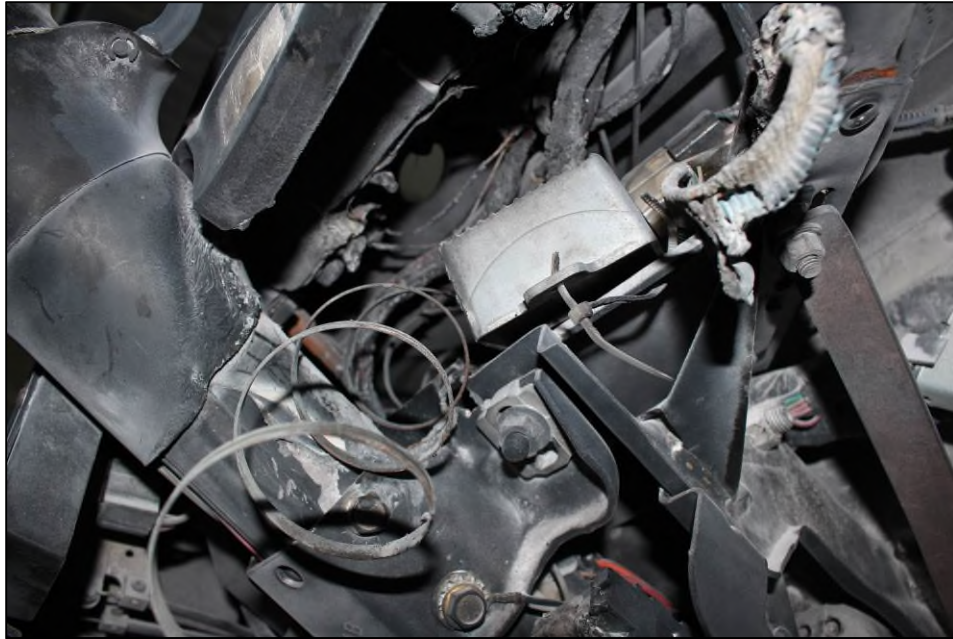
Photograph 7
Under dashboard.

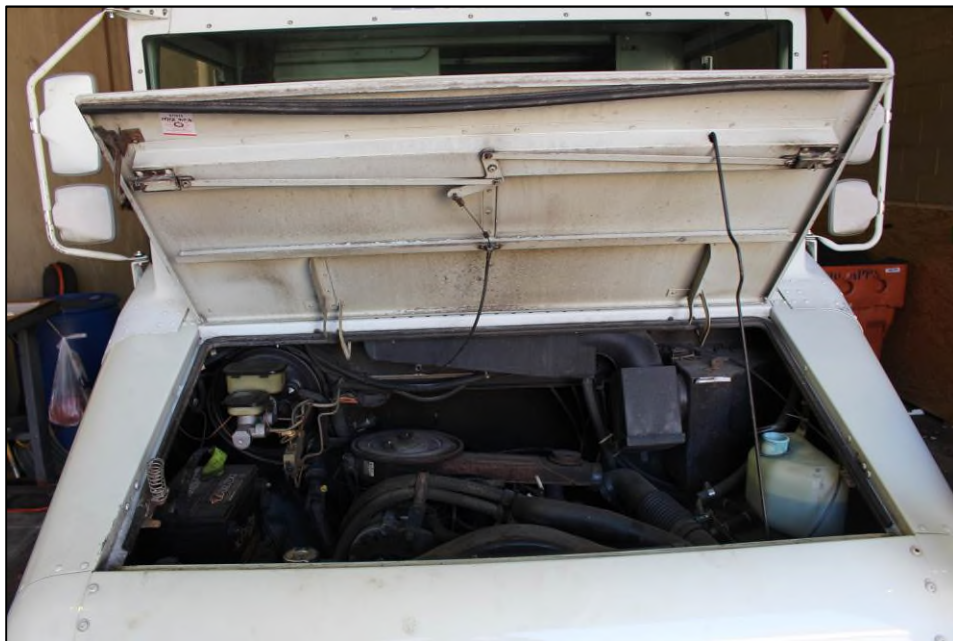
Photograph 8
Engine compartment.

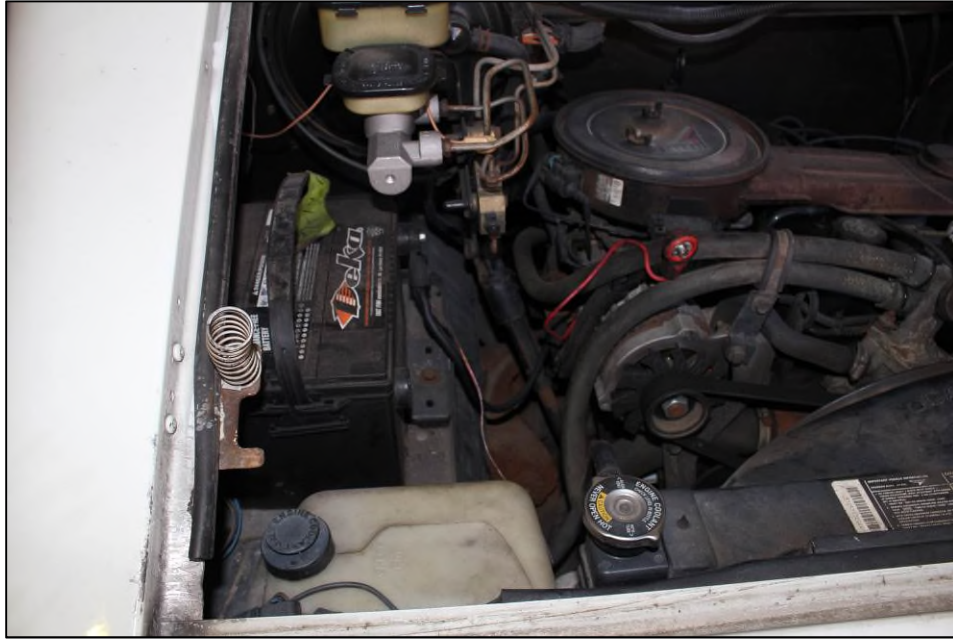
Photograph 9
Battery and ground wire.

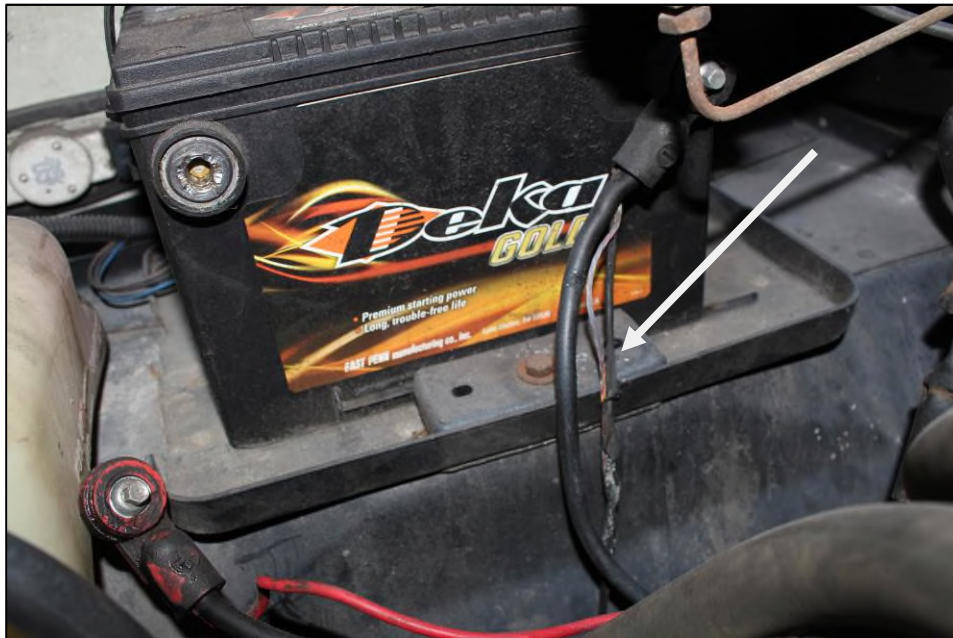
Photograph 10
Melted ground wire.

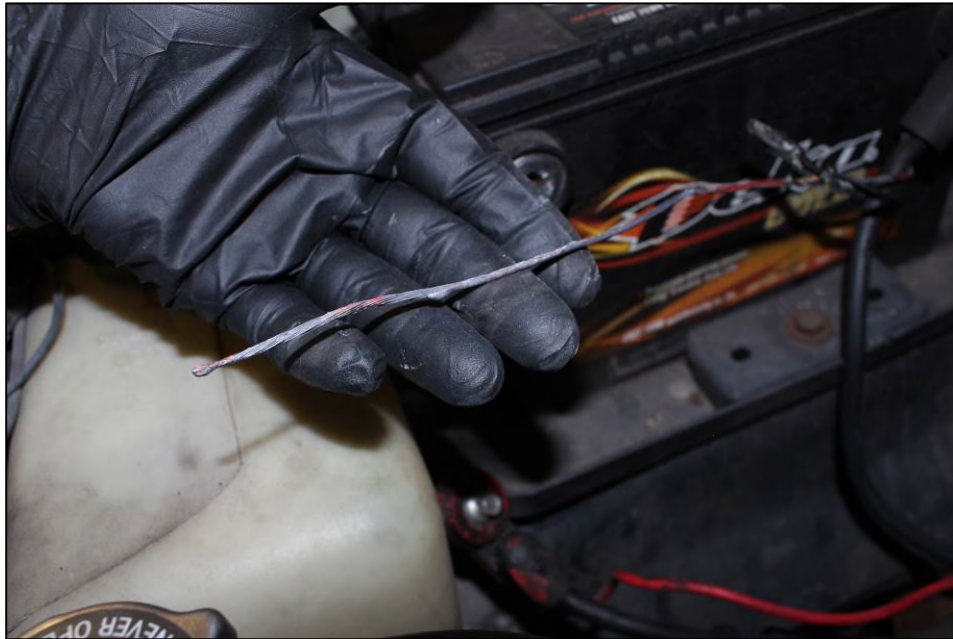
Photograph 11

Melted ground wire from battery.

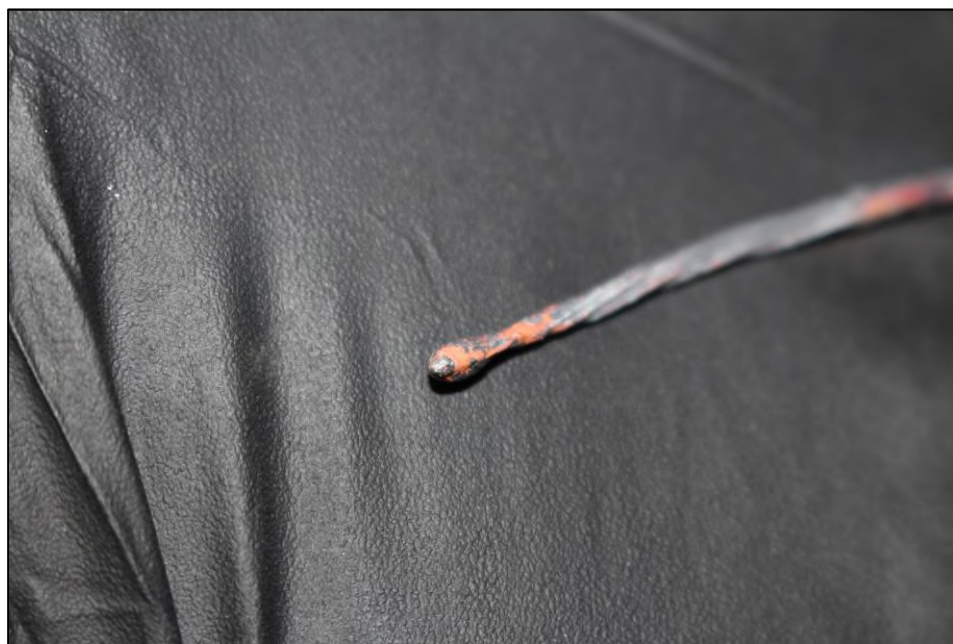
Photograph 12

Melting of ground wire.

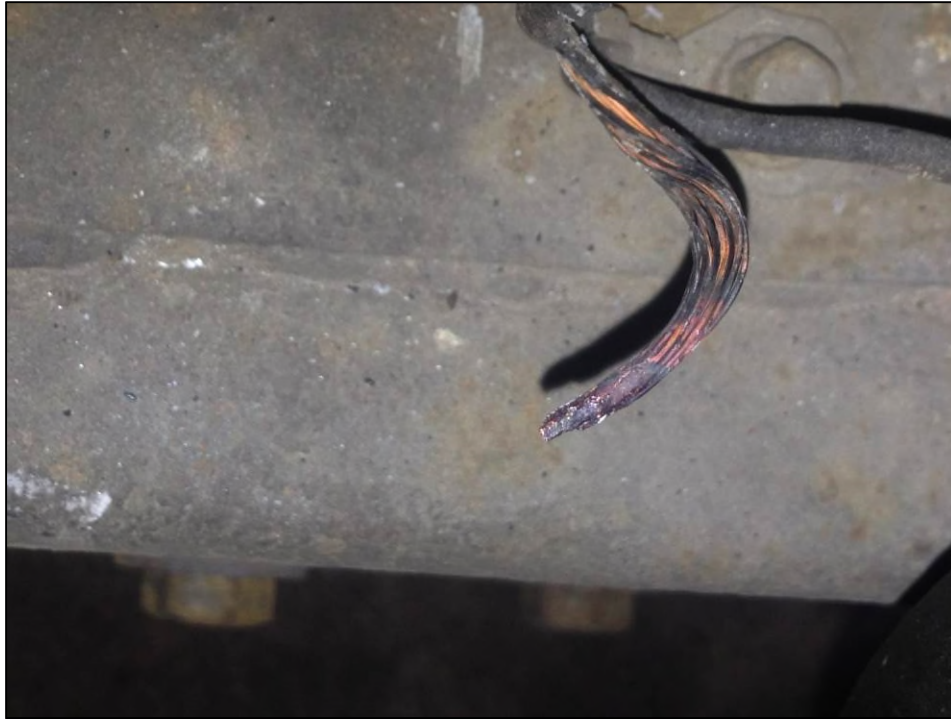
Photograph 13
Ground wire severed.

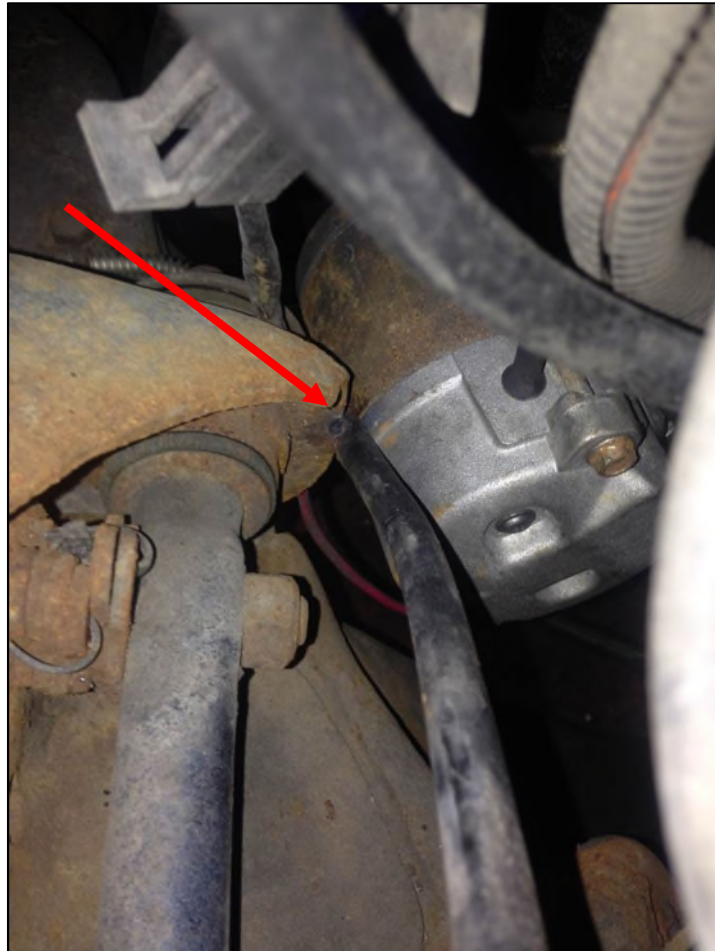
Photograph 14

Negative conductor pinched between starter and frame.

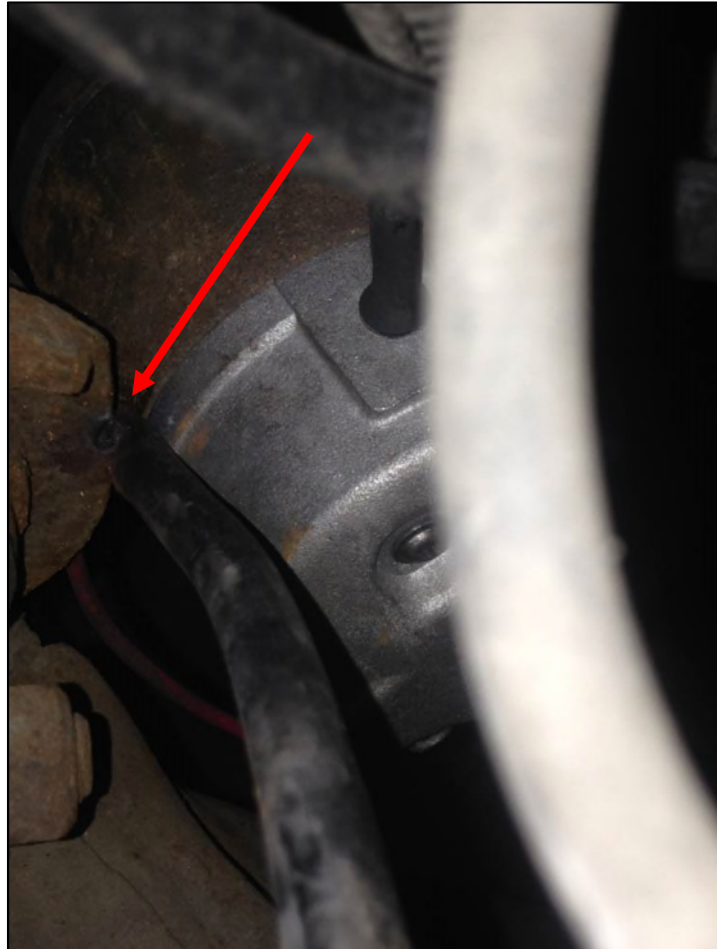
Photograph 15

Close up view of negative conductor pinched.

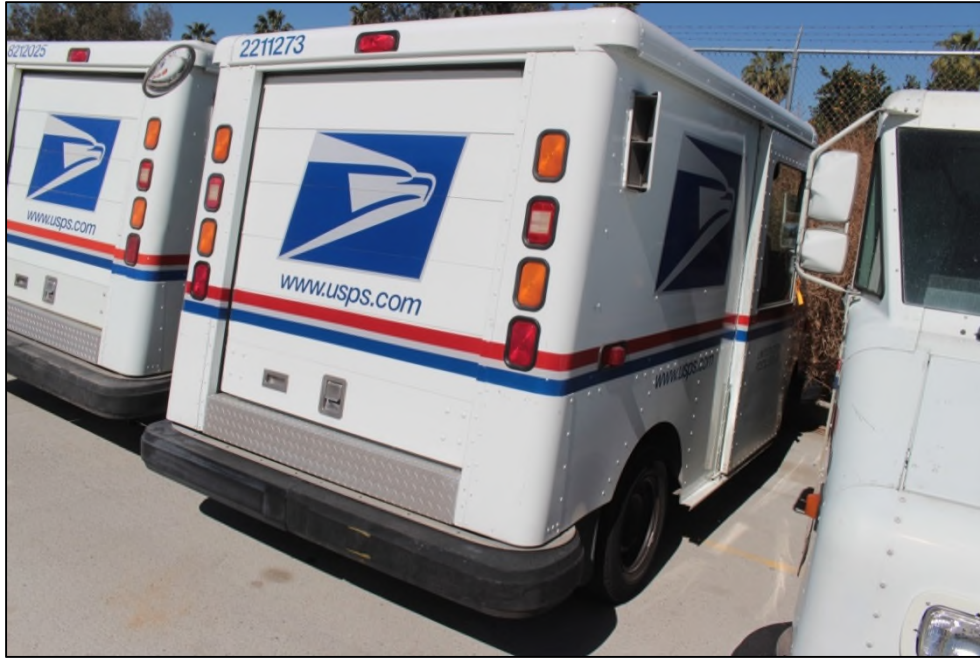
Photograph 1

LLV 2211273. No exterior fire effects.

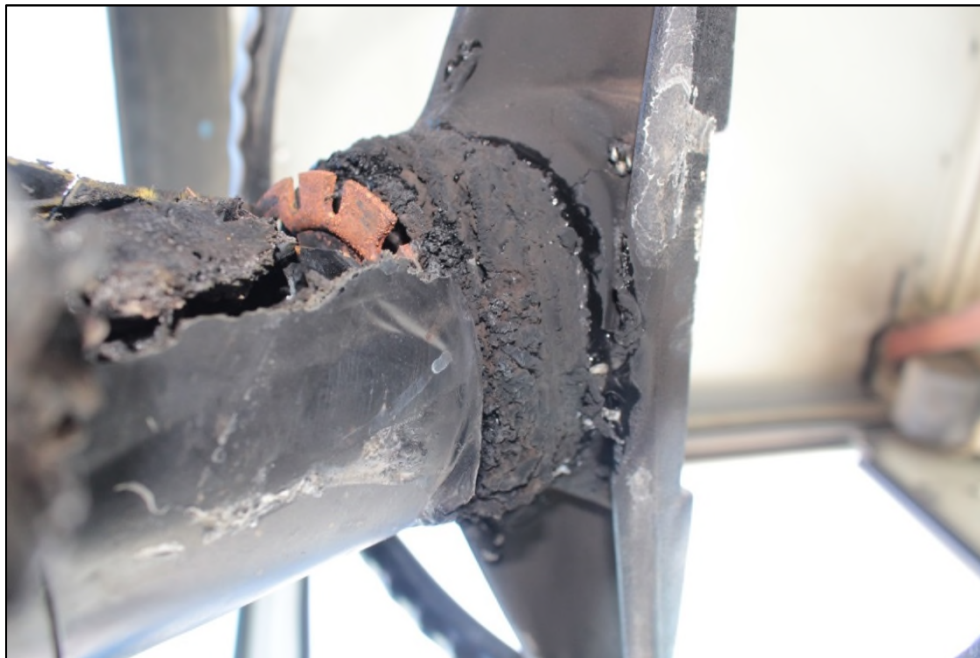
Photograph 2

Underside of steering column. Fire department cut open left side for access.

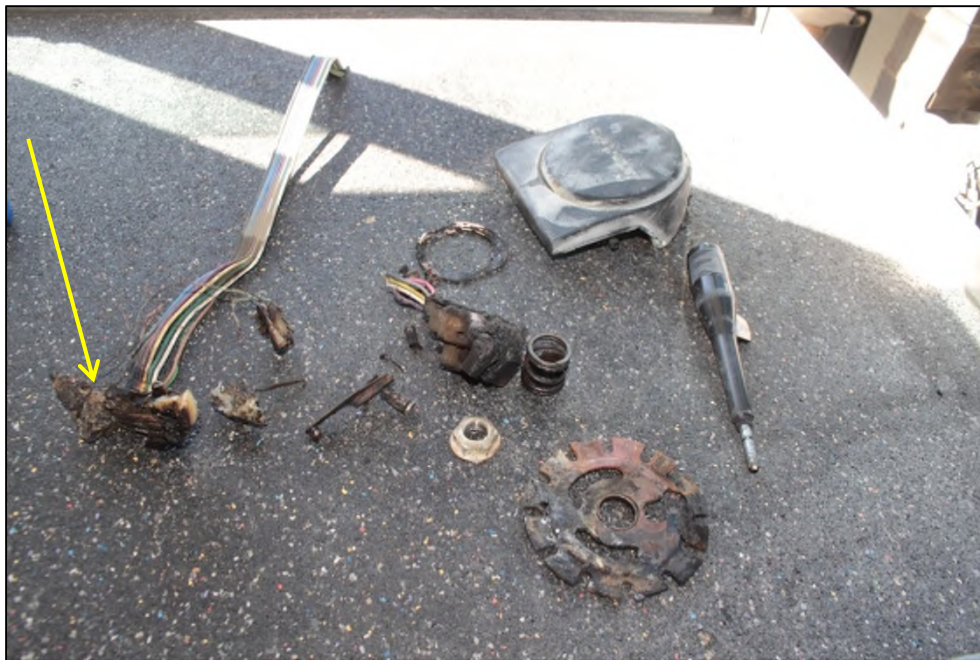
Photograph 3

1. The fire was determined to have originated in the steering column of the involved LLV.
2. The specific area of fire origin was determined to be at the horn ring assembly.
3. The specific ignition sequence and cause of the fire was determined to be the direct result of the metallic horn ground contact ring and brass contact button abrasion particles falling into the plastic electrical wiring connector portion of the horn ring assembly. The metallic particles created a high resistance electrical path between conductors which ignited the plastic connector and horn ring assembly.

Evidence items from steering column. Apparent origin component, yellow arrow.

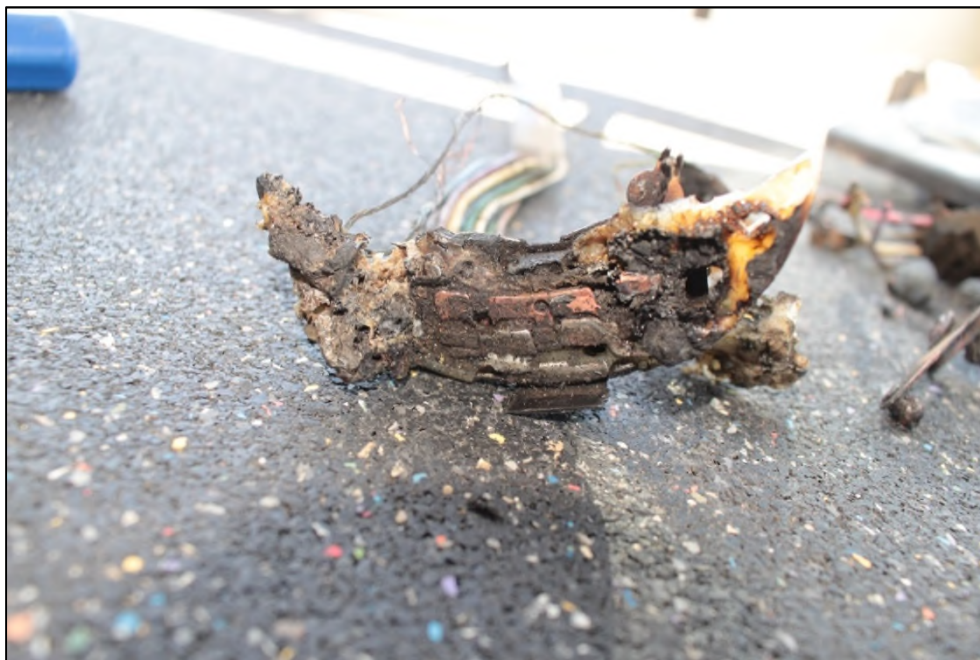
Photograph 4

Normal wear and degradation of the components located within the area of origin where the horn ring and related brass contact friction generated metallic particles/dust which accumulated on adjacent energized electrical circuitry.

Closer view of apparent origin component.

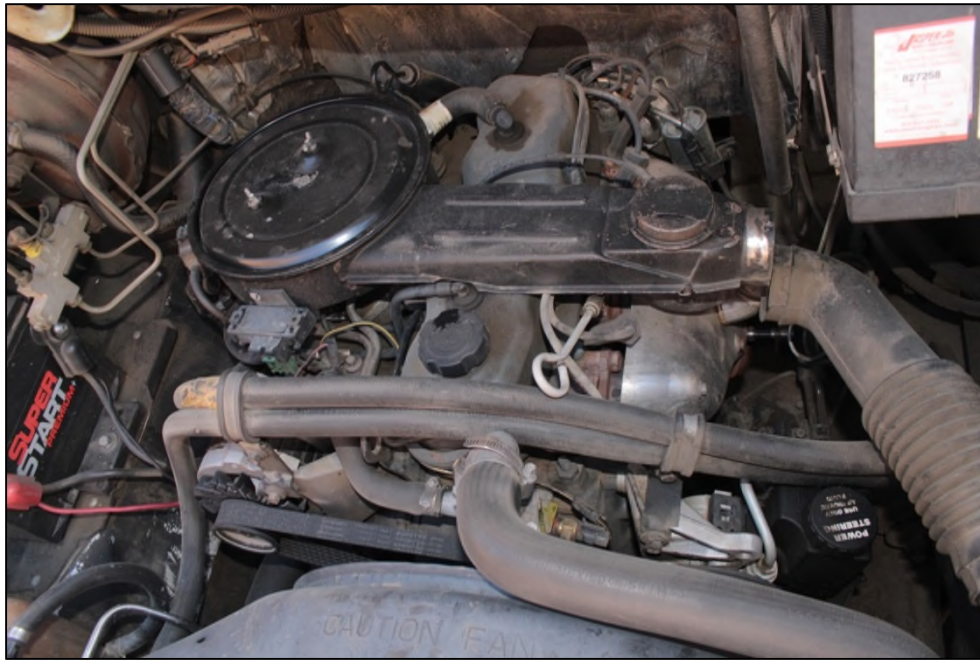
Photograph 5

Engine Compartment. No fire damage observed.

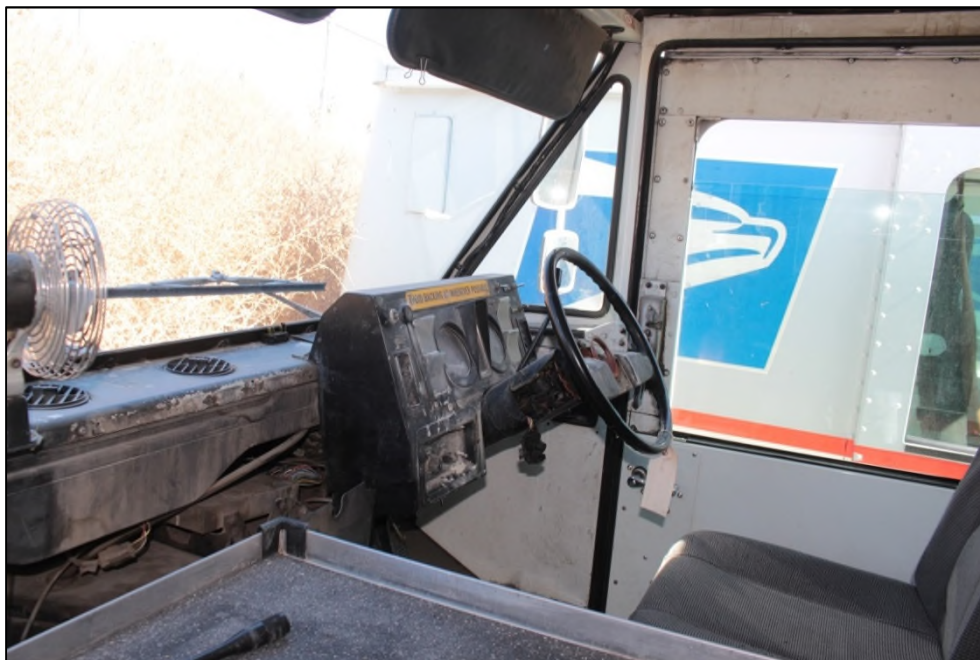
Photograph 6

The operator's compartment. No damage except to steering column.

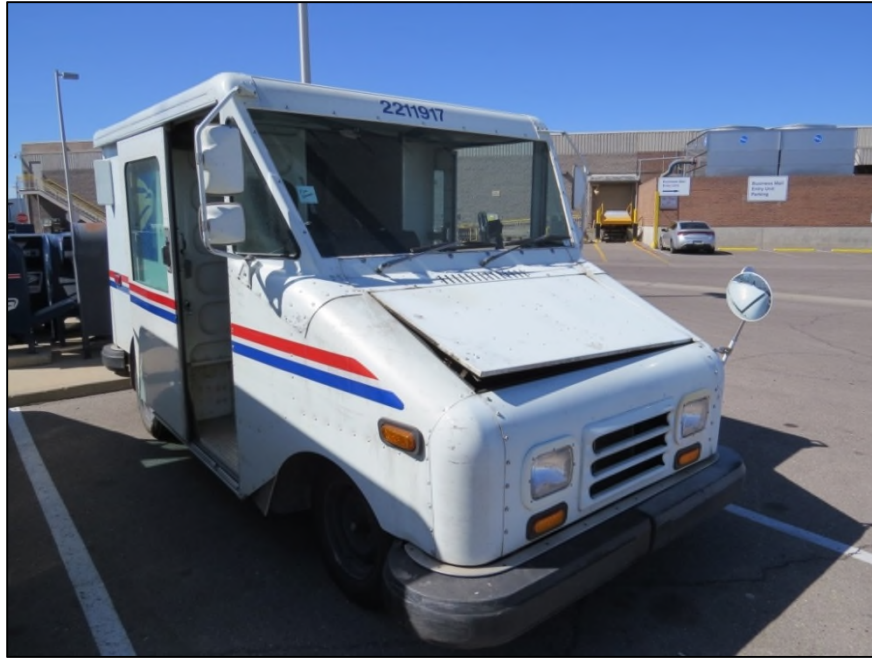
Examination of the vehicle began at the front exterior and continued in a clockwise direction. Exterior fire damage was confined to the driver side of the hood and consisted of heat blistering to a small section of paint. There were no obvious signs of pre-fire collision damage.

Photograph 1
Front of LLV 2211917.

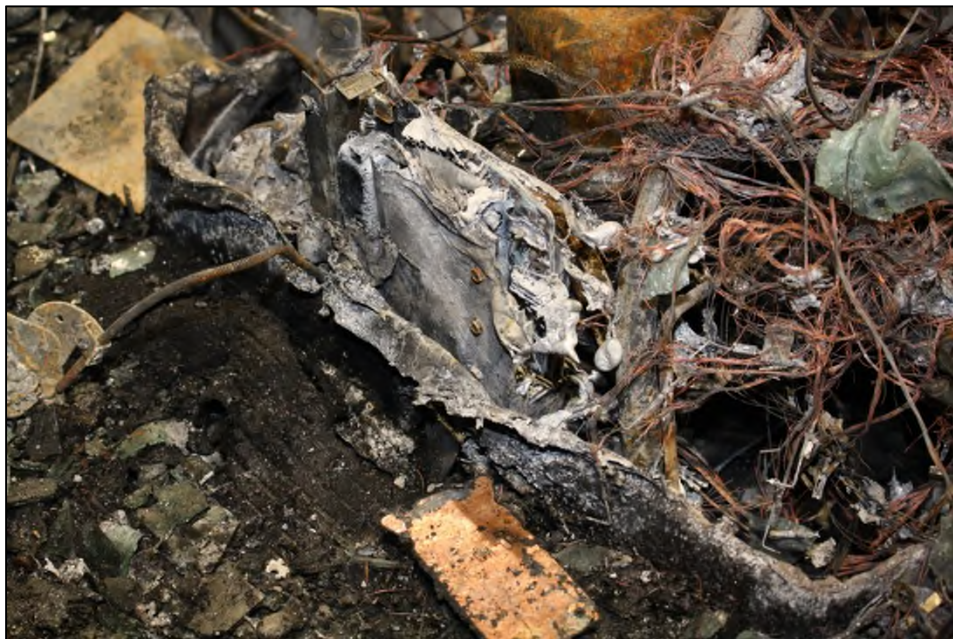
Photograph 2
Area of origin.

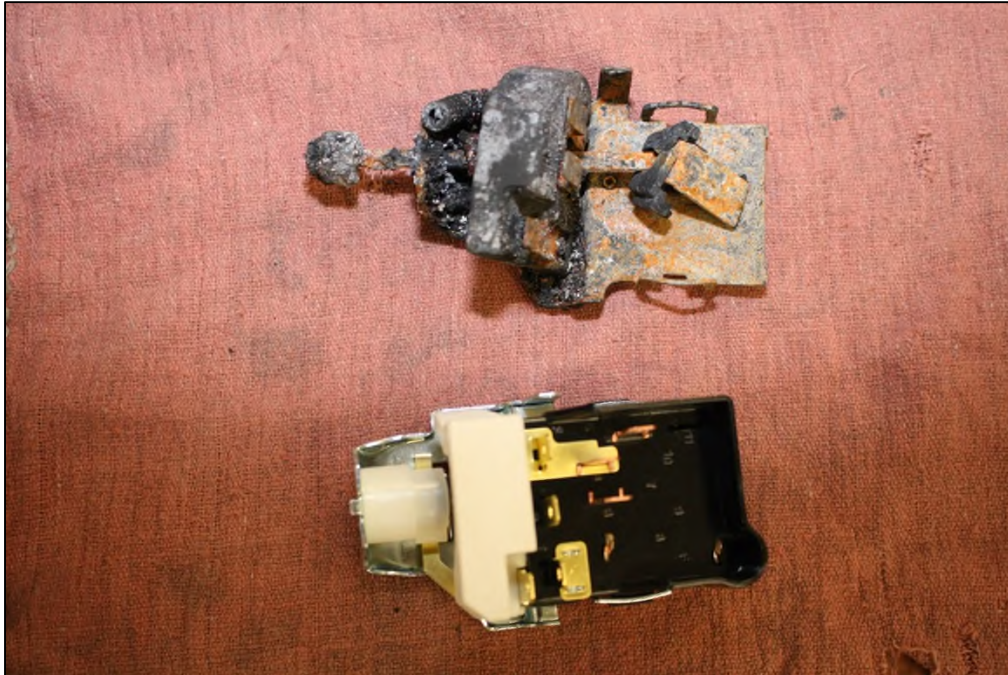
A failure of the headlamp rheostat switch contributed to the cause of the fire.

Photograph 5
Headlight switch.

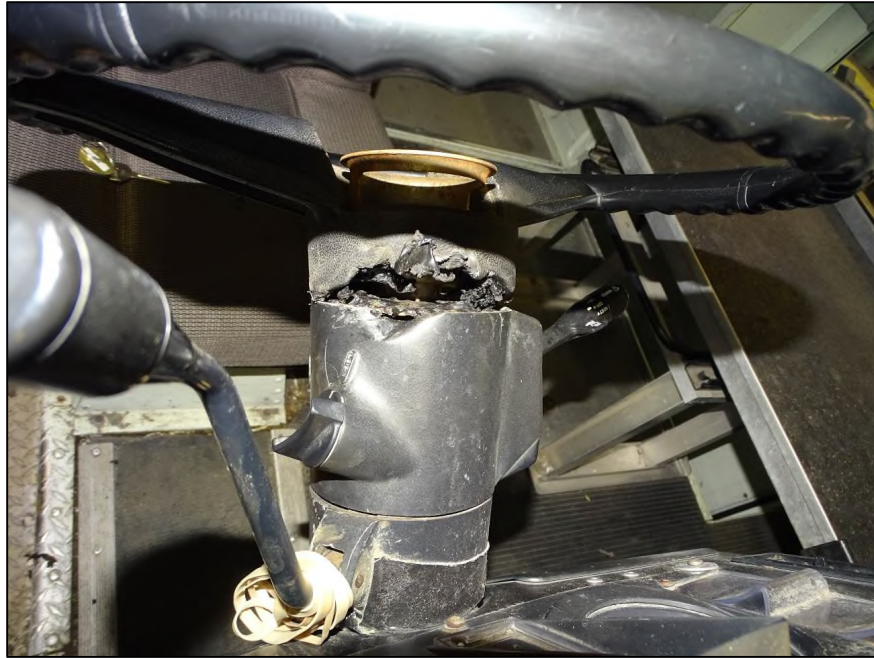
Photograph 3

Fire damage at the steering column.

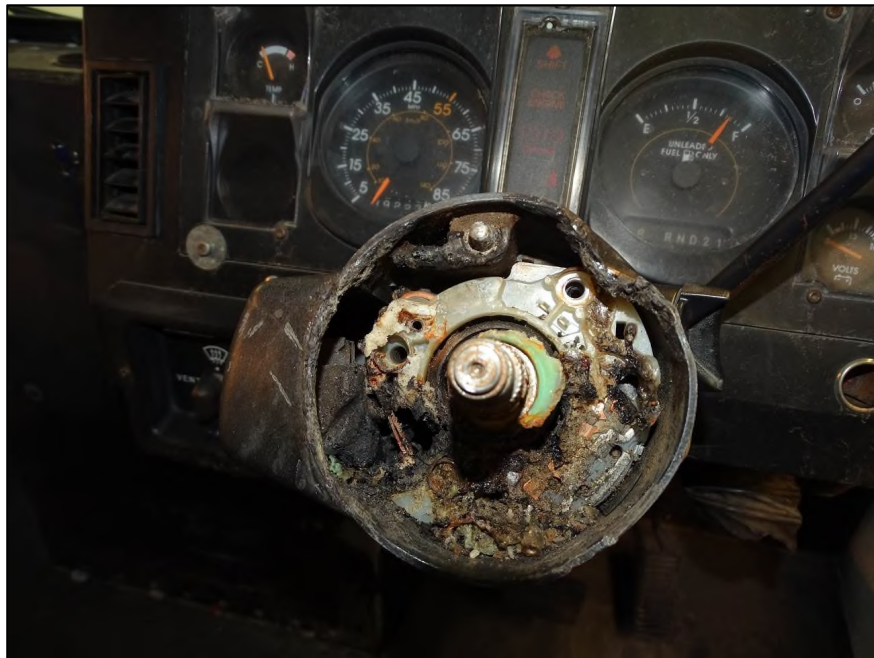
Photograph 4

Remains of turn signal assembly.

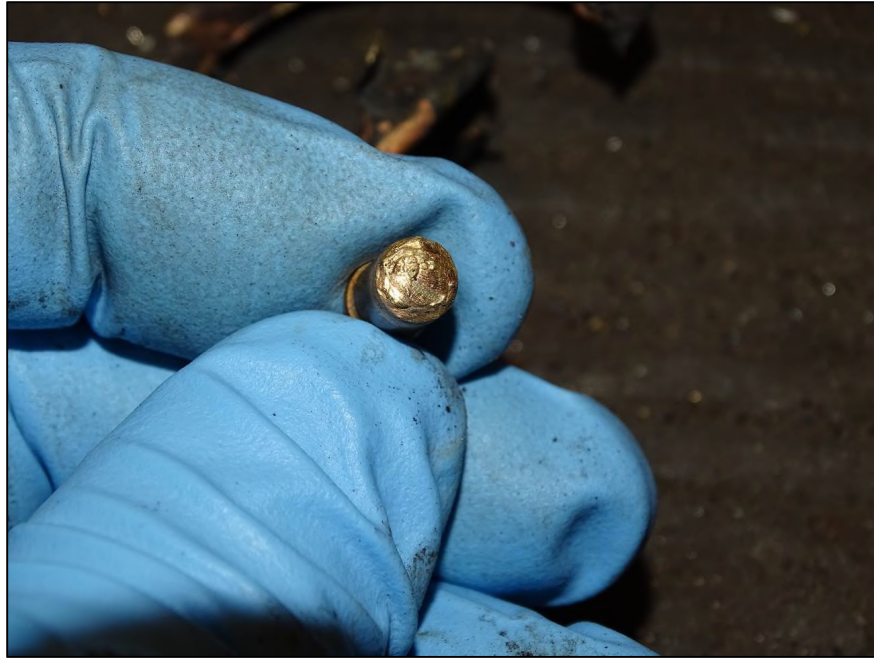
Photograph 5
Remains of horn button.

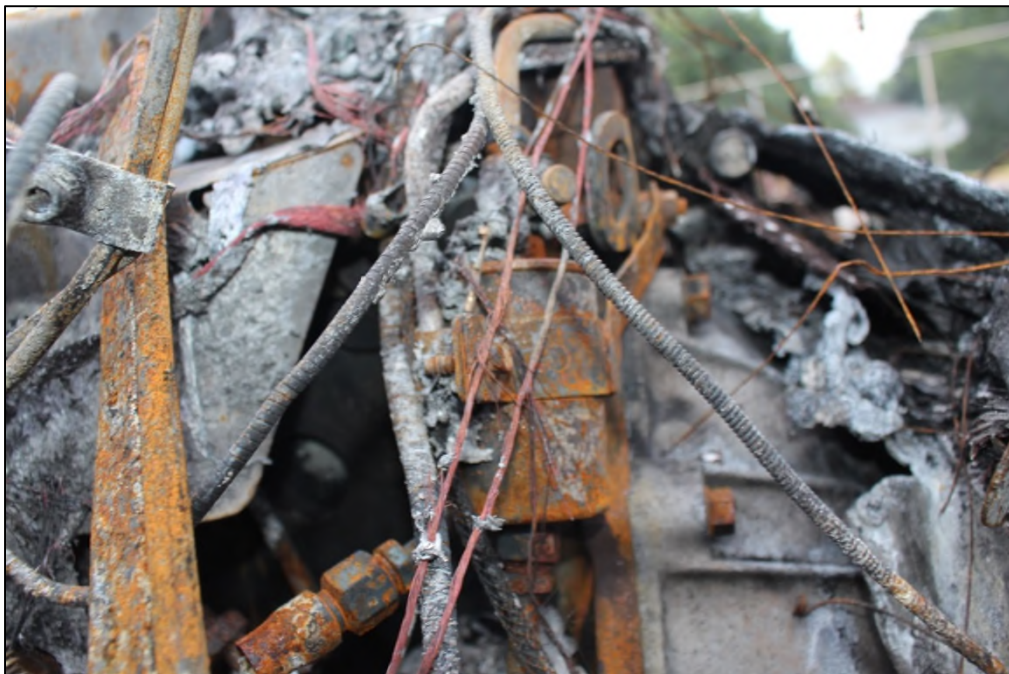
Photograph 6

View of the fuel filter.

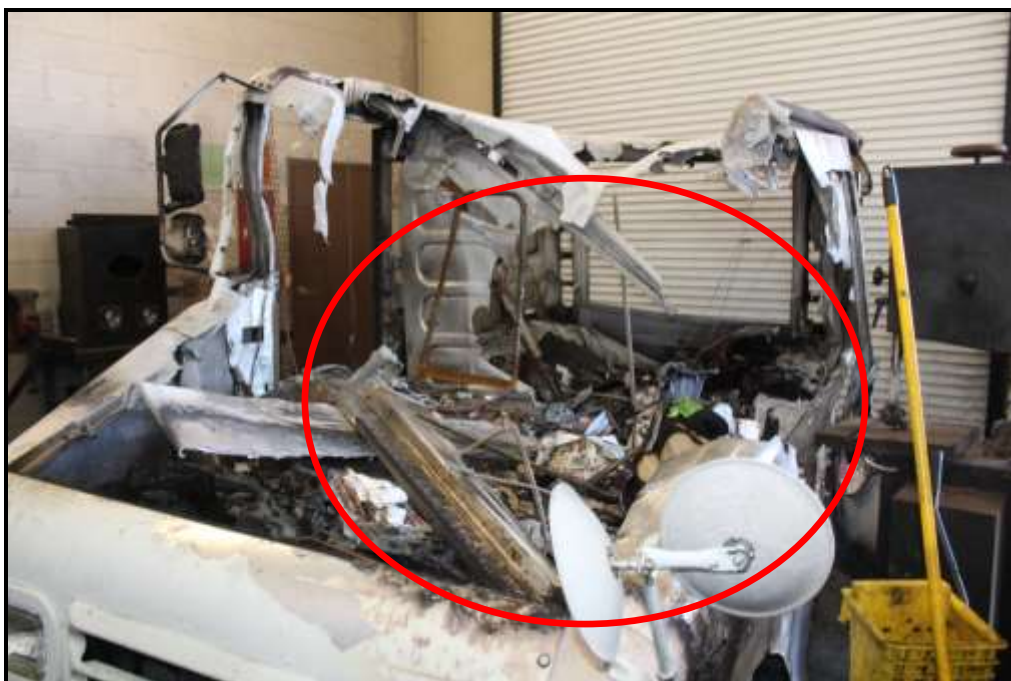
There was severe fire damage to all portion of the engine compartment. The most severe fire damage and mass loss was on the mail side in the area of the bulkhead. Based on the burn patterns observed, it was determined that the fire progressed upward and outward from the area of the bulkhead on the mail side and throughout the engine compartment. No indications were observed that the fire originated within the engine compartment.

Photograph 2
Most severe fire damage to the mail side bulkhead area.

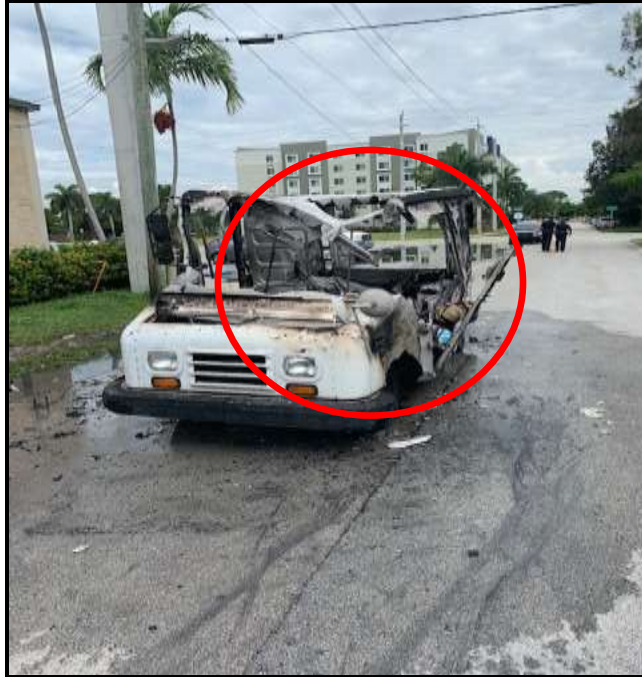
Photograph 3

Burn patterns observed indicated that the fire originated on the mail side of the vehicle at the dashboard area and progressed upward and outward from this location into the interior and engine compartments.

Fire scene photo, observed the most severe fire damage to the mail side.

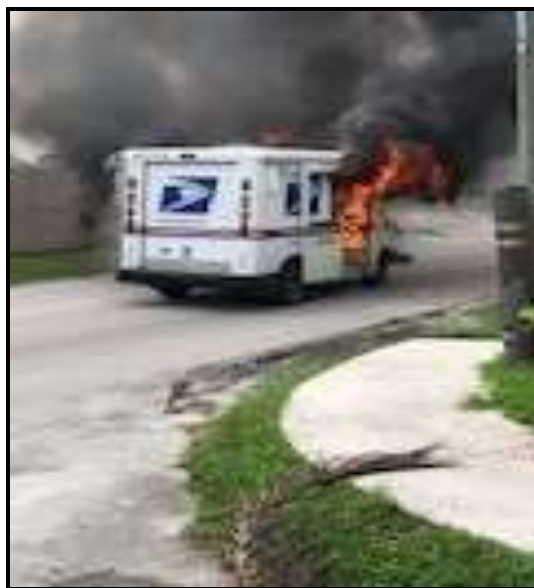
Photograph 4

Fire scene photo, observe fire within the interior compartment.

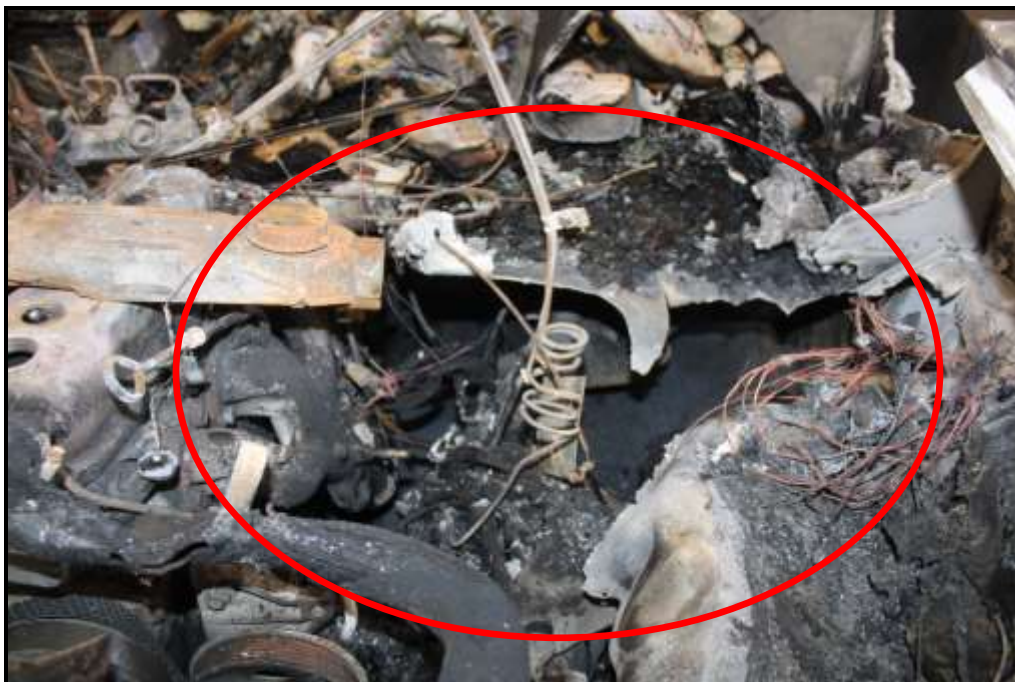
Photograph 6

The mail side of the engine compartment, mass loss to the bulkhead area.

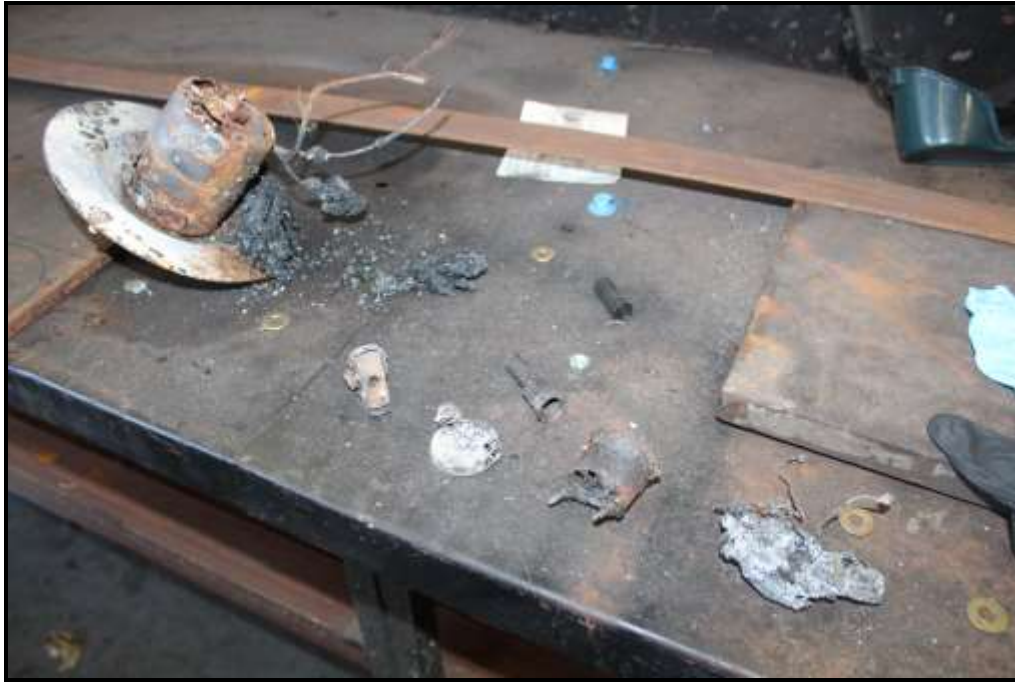
Photograph 7

The remains of the auxiliary fan were observed in the fire debris and examined. The fan was observed with severe fire damage and mass loss. The fan motor was unable to be turned indicating it may have failed prior to the fire. However, due to the lack of remaining physical evidence it was inconclusive as to the failure of the fan.

The auxiliary fan and components.

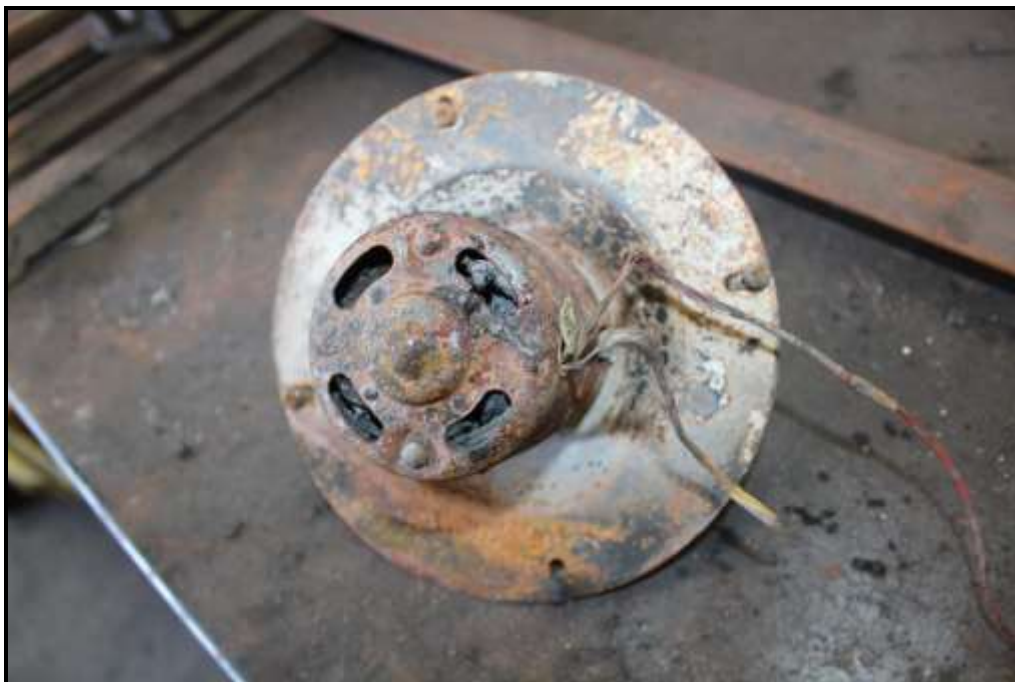
Photograph 8

The auxiliary fan.
